# Manhole Inspection Summary

Manhole # S43OO\_023MH

Insp Date: **12/14/07 11:32 AM**

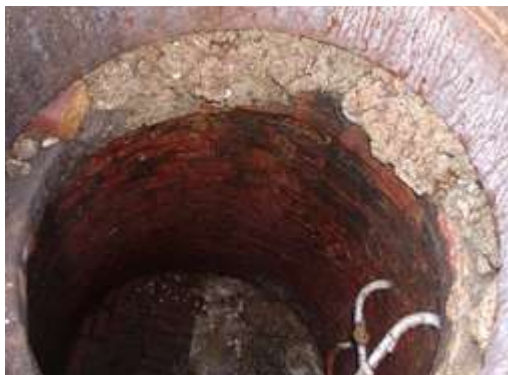
Defect 1

**Frame** Offset: **0** (in.) Condition: ☐ Sound ☐ Cracked ☒ **Leaks**

Condition: ☐ Sound ☐ Cracked ☐ Root Intrusion ☒ **Loose Brick** ☒ **Deteriorated**

Infiltration: ☐ None ☒ **Joint** ☐ Cracks ☒ **Mortar** ☐ Roots ☐ Wall

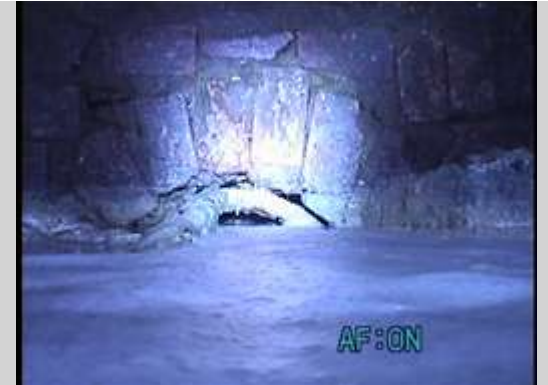
12 O'Clock Outflow

8 in. Circular Gravity Sewer  
Pipe Out @ 12 O'Clock

Pipe Height: **8.4** (in.) Rod and Bar (Angled)  
Pipe Material: **Clay** ☐ Pipe Lined  
Invert Depth: **9.00** (ft.) Flow Characteristics: **None**  
Deposits: ☒ None ☐ Mud ☐ Sludge ☐ Debris ☐ Grease  
Silt Depth: (in.) Deposits Extent:  
Infiltration: **None** Pipe Seal Cond: **Sound**

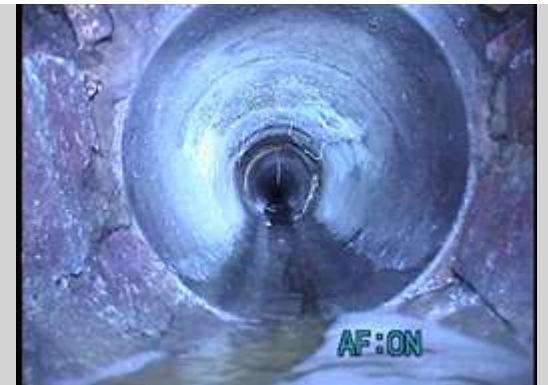
3 O'Clock Inflow

8 in. Circular Gravity Sewer  
Pipe In @ 3 O'Clock

Pipe Height: **8.4** (in.) Rod and Bar (Angled)  
Pipe Material: **Clay** ☐ Pipe Lined  
Invert Depth: **8.60** (ft.) Flow Characteristics: **None**  
Deposits: ☒ None ☐ Mud ☐ Sludge ☐ Debris ☐ Grease  
Silt Depth: (in.) Deposits Extent:  
Infiltration: **None** Pipe Seal Cond: **Sound**
